Smoke and Dye Testing Summary

High Level Sewershed

Run Summary

| Test ID | Test Type | Date Inspected | Company / Super. | Blower MH | Ground Condition | Notification Made? | Total Length |
|---|---|---|---|---|---|---|---|
| S1028-228 | Smoke | 8/11/2009 | ADS/TM | S23MM_031MH | Dry | Yes | 724.74 |

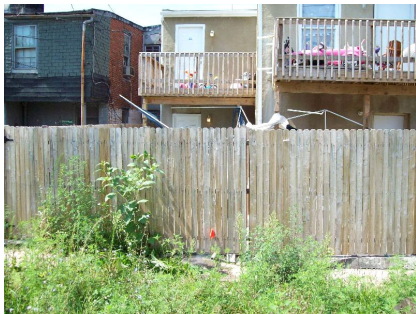
Picture \S1028-228-OB01-P01.jpg

Comments Smoke from driveway drain in paved concrete in back yard. 2537 Woodbrook Ave.

Comments Back of house, 2537 Woodbrook Ave.
